# Geo-historical Appraisal of Embankment Breaching and Its Management on Active Tidal Land of Sundarban: A Case Study in Gosaba Island, South 24 Parganas, West Bengal

#### Abstract

**Keywords:** Embankment Breaching; Vulnerability Assessment; Fluvio-hydrological Challenges; Management Techniques; Sundarban; 24 Parganas, West Bengal; India

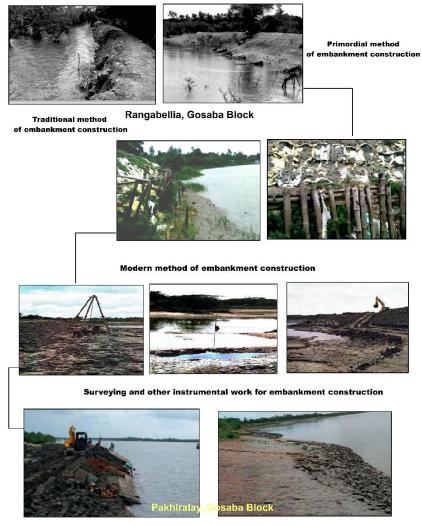
**Block pitching**

Figure 3: Embankment Construction from Past to Present Source: Field Survey (12-02-2019 to 20-02-2019)

sequential change found in the construction of embankment during minutely field surveying (Figure 3).

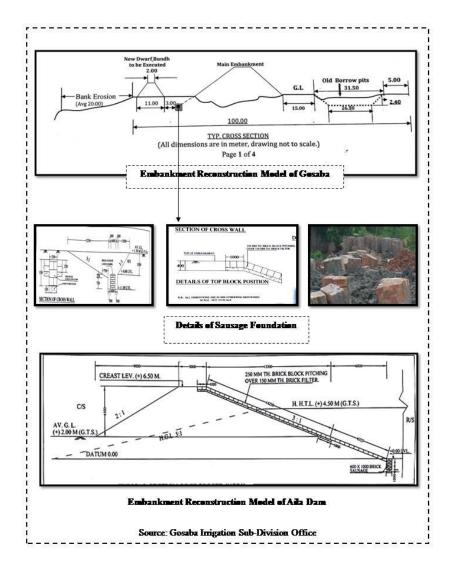
Embankment Reconstruction Model of Aila Dam Figure 4: Recent Engineering Model of Embankment Source: Gosaba Irrigation Sub-Division Office

Embankment may refer to a levee or an artificial bank, mainly elevated from the surrounding parts of the land to prevent flooding by a river, lakes or sea. Embankments may either made by earthen materials or bricks and concrete materials (Das, 2016). The construction of embankment in Sundarban is still a difficult task due to the hydro-geomorphic diversity of the land. The texture of the soil in the studied region is mainly silty clay and clayey soil. The bearing capacity of these types of soil is very low. Therefore, technological expertise is required for heavy embankment construction. At present, synthetic Geotextile and Jute Geotextile are frequently used as filter layer in the embankment construction. The average height of typical embankment is 3 metre from mean sea level, protected by a small dwarf Bundh. This Bundh protects the main embankment from the direct tidal current. A sausage, made by brick blocks is constructed under the ground and below the riverward edge of the main embankment to increase the longevity of the embankments. The river side and country side slope of the embankment are 3:1 and 2:1 respectively. On 23 May 2009, Aila, a severe tropical cyclone wind speeds of 110kmh (70 mph) produced not only natural disaster but proved that the height of the embankments fail to protect the deltaic people of Sundarban during environmental extremes as the region remains below the high tide line. Therefore, the heights of the embankments have been raised in

some places from 3 metre to 6.5 metre to save the inhabited coastal part from flood water inundation. This type of elevated dam is locally known as Aila dam (Figure 4). The Aila dam is commonly found in various parts of Gosaba Island like Bagbagan, Bally and Satjelia. However, the construction and management of the embankments in these dynamic islands is still a big challenge for engineers and planners.
